ENV4-CT98 0708 REACH

Rationalised Economic Appraisal of Cultural Heritage

Case Study of "Kristiania Kvadraturen" in Oslo

NILU: OR 26/2001
REFERENCE: U-97112
DATE: MAI 2001
ISBN: 82-425-1264-7

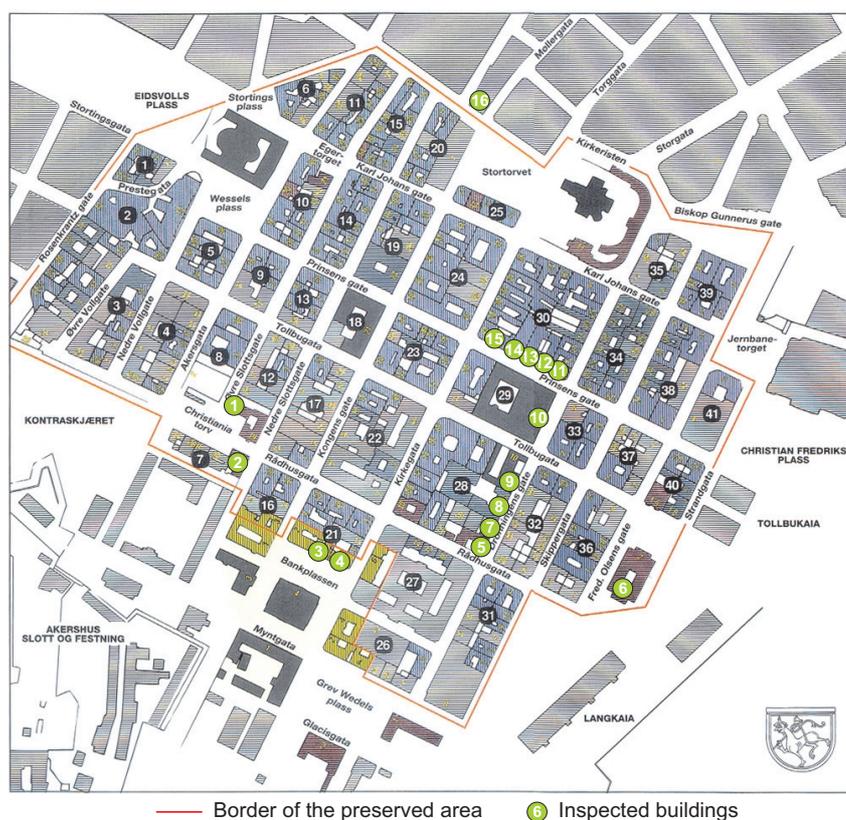
Figure 1: The preserve area “Kristiania Kvadraturen” with the inspected buildings marked. (Fortidsminneforeningen, 1996).

The area “Kvadraturen” and the selected buildings are shown in Figure 1. In total 16 buildings were inspected. 8 of the buildings were built between 1626 and 1800, the remaining were from 1800 to 1914.

The sources for the short history given for the buildings are two Norwegian books (Fortidsminneforeningen, 1996 and Bruun 1999), where a more complete description of the buildings and their history is given. The description given in the following chapters is following the numbering given in Figure 1.

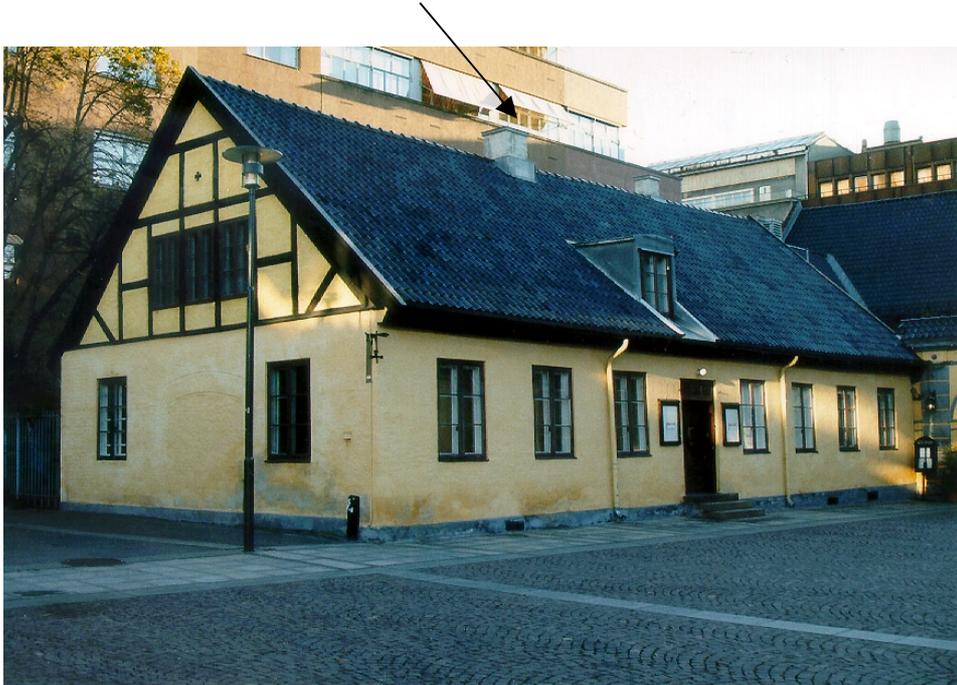
5.1 Rådhusgata 19, the annex

The building was built in the 1640-ies and is the oldest half-timbered house with calcareous rendering in Oslo. The house has one floor and an attic. It was originally a private home, but has had different owners and different use during the history. The house is to day used for exhibitions by Young Artist Society (UKD).

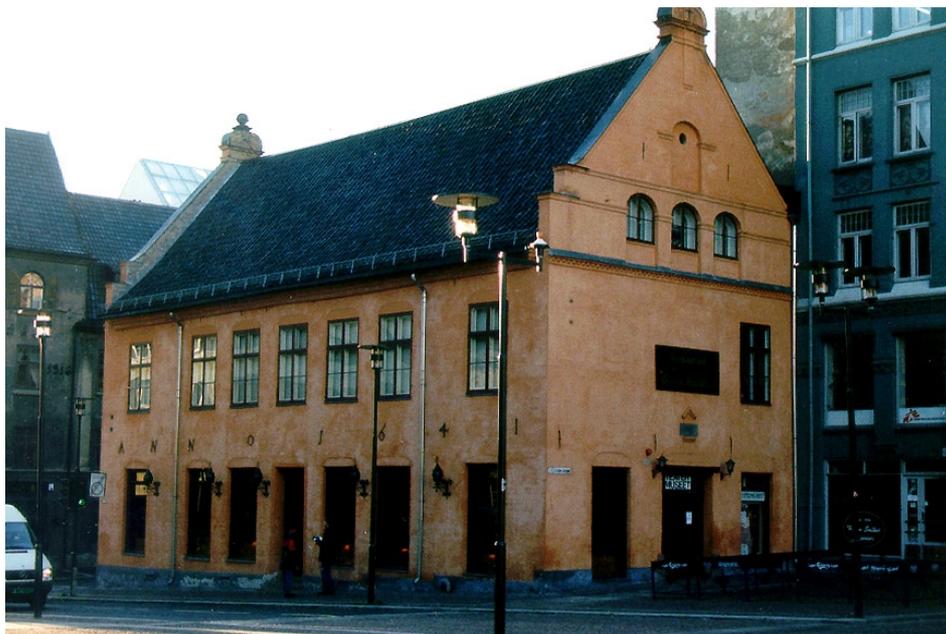
5.2 Nedre Slottsgate 1

The building was built in 1641 as the city hall of Christiania (Oslo), and was used as city hall up to 1733. A wing was attached in 1850-ies as a restaurant. The house has two floors and an attic. The building was partly destroyed by a fire in 1996 and has been restored to its original construction. The owner of today is the City of Oslo and the building contains one museum and one restaurant.

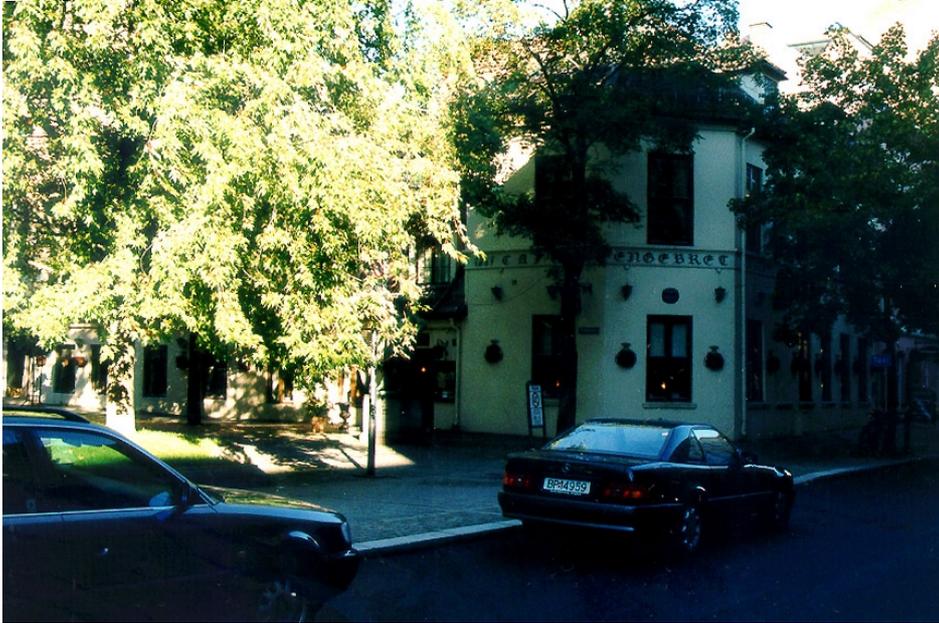
5.4 Bankplassen 1B

The low part of the building is facing the square and was built in 1760 with one floor and an attic. The wing towards the street (Kirkegata) was built in 1814 with two floors and an attic. The building is private owned and contains the oldest existing restaurant in Oslo, Engebret Café from 1857. The building was restored in its old style after a fire in 1921.

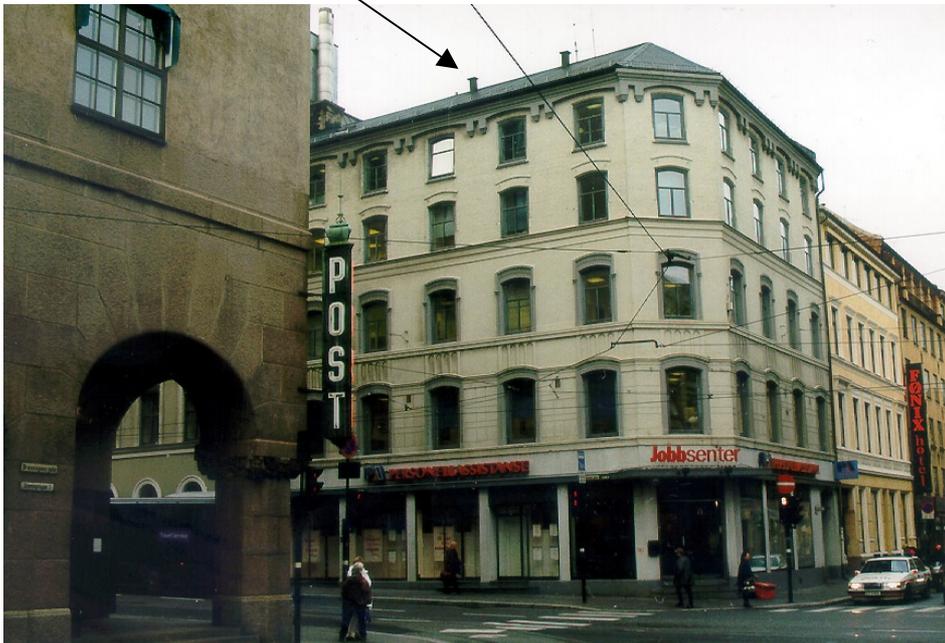
5.11 Prinsens gate 5

A fire destroyed the whole block between Dronningens gate and Kirkegata in 1858. The building of today was built in 1860, but some re-constructions have been carried out. The fourth floor was re-constructed in 1876 with larger windows. The ground floor was changed both in 1891 and 1932, and modern windows were installed in 1980. The house is private owned and is used for shops and offices.

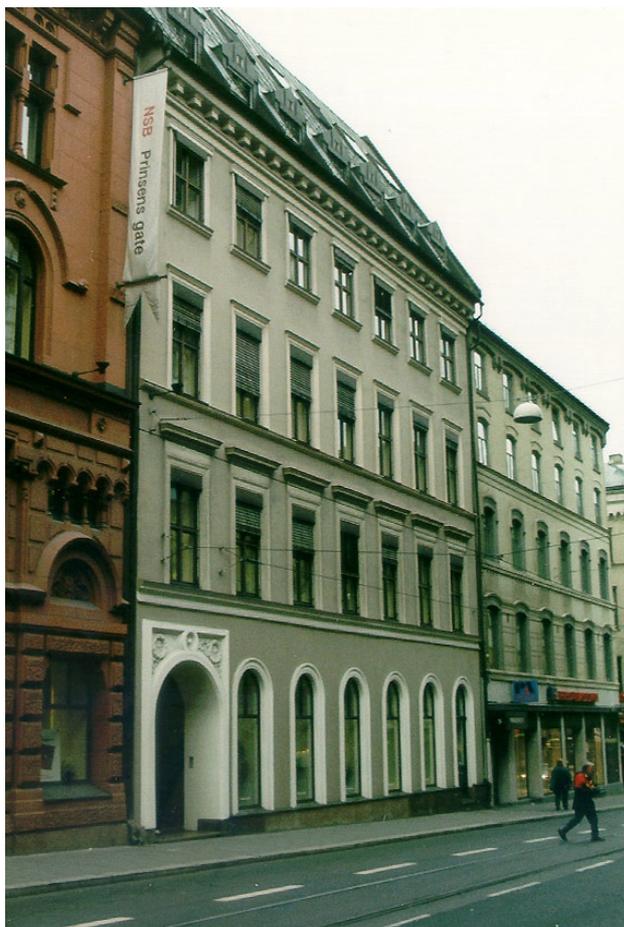
5.12 Prinsens gate 7

The building was built in 1860 as a private house with a repair shop in the backyard. A big re-construction was made in 1985. Only the façade was kept more or less as original. This re-construction was one of the cases that started the process for the later protection act for the area. The building is private owned and is used for offices.

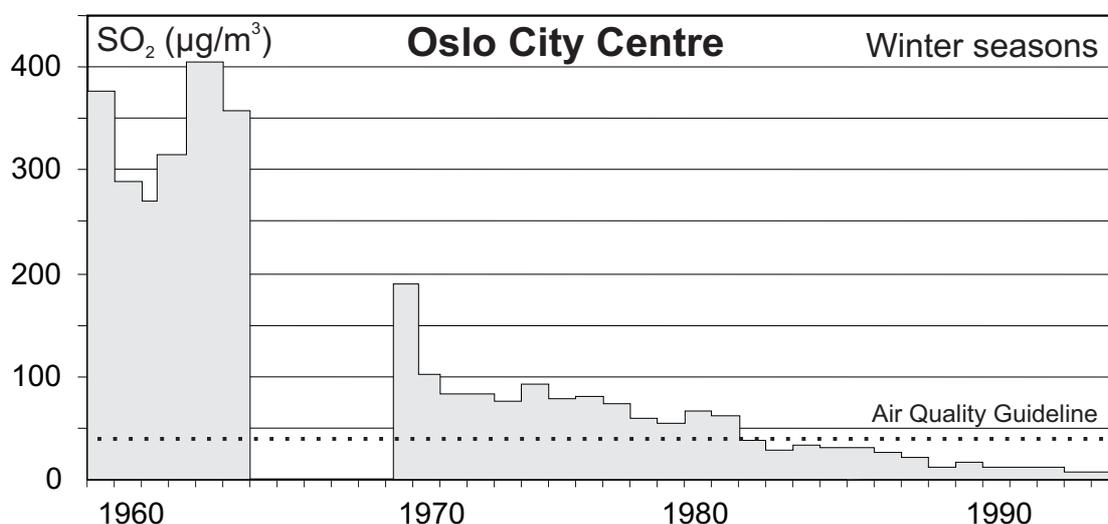
Figure 2: Winter concentration of SO₂ in Oslo city from 1958 to 1995. The Norwegian recommended Air Quality Guideline is given (Larssen, 1998).

As seen in Figure 2 a great improvement has been obtained for the SO₂ pollution during the last part of the 20th century. The main pollution problem in Oslo today is linked to particles from traffic and heating with wood stoves during the winter and NO₂ mainly linked to the traffic. Before 1990 the main traffic between east and west went through Rådhusgata. In 1990 a tunnel was built to reduce the traffic impact in the old part of the city.

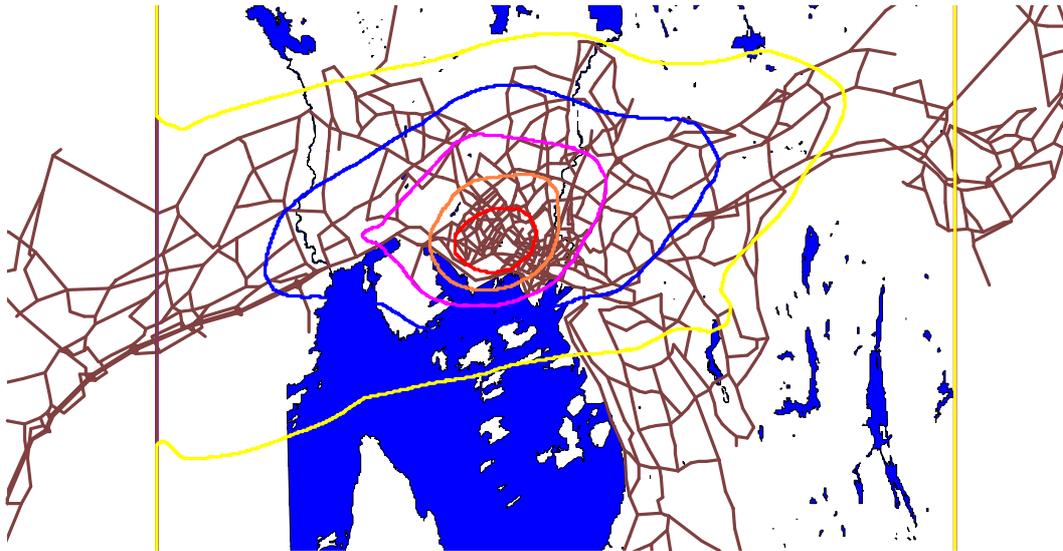
Figure 3: SO₂ concentrations for Oslo in 1979. Iso-lines for 5, 25, 35, 45, 55 µg/m³.

The concentration maps for Oslo are given in 500x500 m grid squares for SO₂ and NO₂. A modelling programme, KILDER, was used for creating the input parameters. KILDER is designed for calculation long time average values based on emission data from different emission sources and meteorological parameters (Gram, 1996). The results were imported into the CorrCost model for further calculation of lifetime and corrosion costs and for presentation of the pollution levels as maps. Figure 3 gives the SO₂ concentrations as iso-lines for 1979 and Figure 4 for 1995.

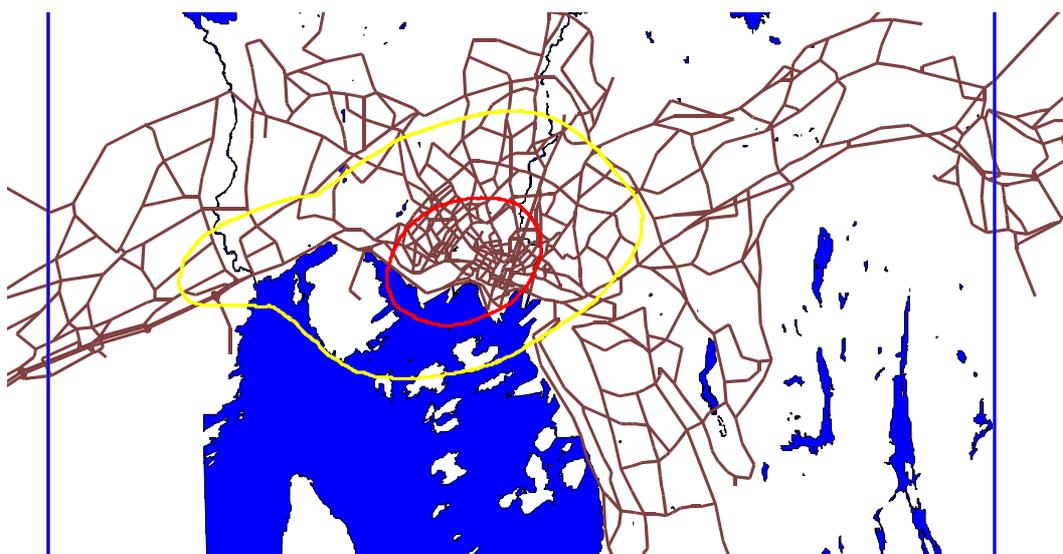
Figure 4: SO₂ concentrations for Oslo in 1995. Iso-lines for 3 and 5 µg/m³.

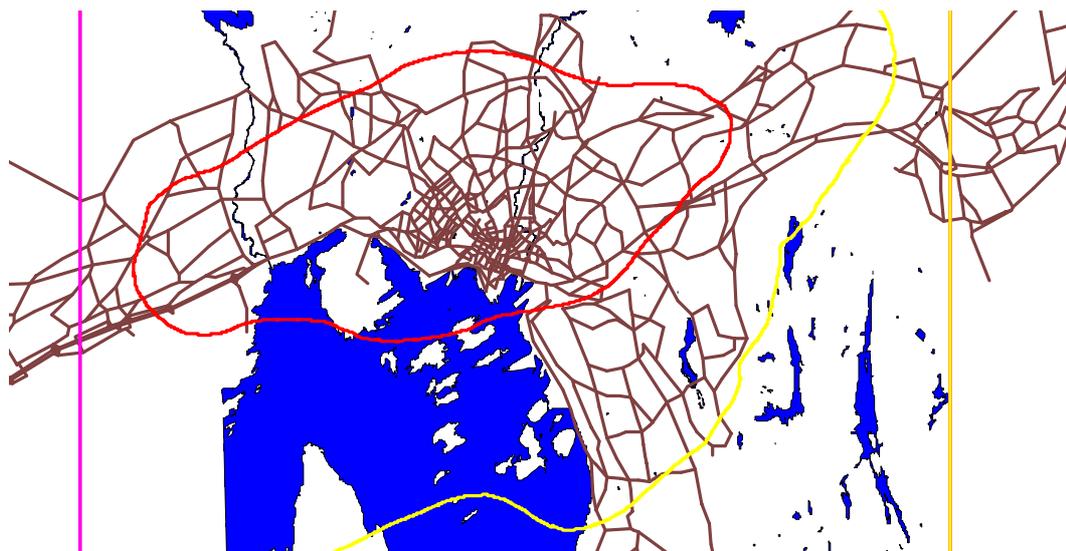
Figure 5: Zinc corrosion in Oslo in 1979. Iso-lines for 7 and 9 g/m².

The CorrCost module of the Reach management tool was used for calculating the corrosion rates in Oslo. The corrosion rates for materials where dose-response equations exist were calculated for both 1979 and 1995. The corrosion results and the % reduction during the period are given in Table 4, and an example of the corrosion variation of zinc through the city is given in Figure 5.

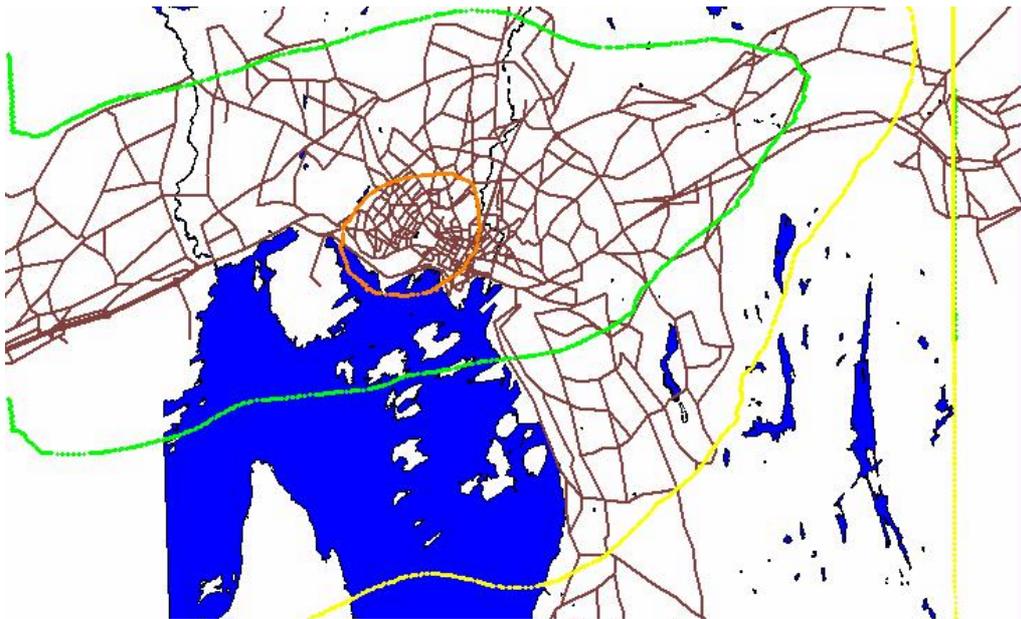
Figure 6: Lifetime for galvanised steel in 1979. The lifetime is defined as the time where the zinc coating was corroded away. The iso-lines are given for 30, 40 and 50 years. 30 years is in the centre of Oslo.

The CorrCost module was also used for calculating the lifetime for materials in Oslo. The lifetimes for both 1979 and 1995 scenarios were calculated. The lifetime results and the % reduction during the period are given in Table 5, and an example of the corrosion variation for galvanised steel through the city is given in Figure 6.
